PLANNING COMMISSION AGENDA REPORT

SUBJECT: PLANNING APPLICATION PA-05-38/PARCEL MAP PM-05-208
2690 ORANGE AVENUE

Per sec.13-42 (f), (2) City of Costa Mesa zoning code. A property review inspection was conducted. The following items were noted. There are 3 units, corrections apply to each unit.

INSPECTION CONDITIONS

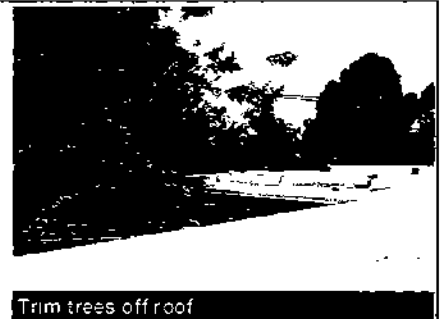
Appears serviceable within useful life with wear consistent for the age of home or material. View was obstructed by foliage- Trim as needed to prevent bald spots and rodents from accessing roof.

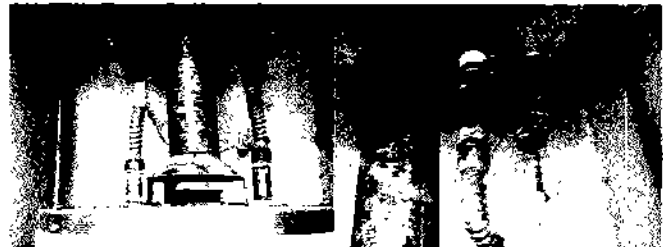
Rear unit

Water heater is not strapped to California Earthquake Guidelines. Recommend two (2) straps, one a third from the top and one a third from the bottom of water heater. Straps should be at least 1.5 inches wide and 16 gauge metal. Pressure relief valve noted, not tested, Pressure relief valve drain line is missing or ends prematurely. This is a SAFETY HAZARD. We recommend this drain line be extended to a safe location, Exhaust vent missing screws or mechanical fasteners connections, Supply line valve is frozen or failed to operate properly and water cannot be shut-off to water heater. Recommend installing a new ball valve on supply line to water heater.

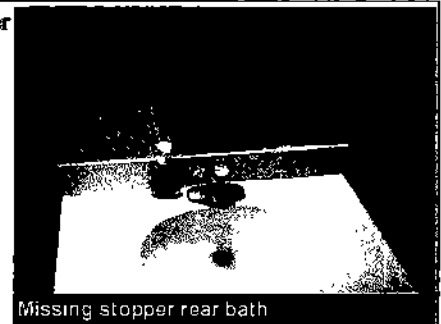
The following problems were noted at the drain: Stopper did not operate properly.

Missing stopper rear bath

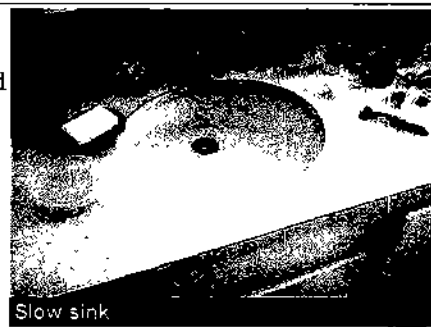
The following problems were noted at the drain:
Drainage is a bit slower than normal. A licensed plumber should be called to make further evaluation and repairs as needed.

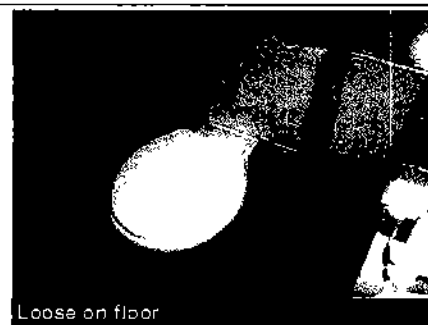
The following problems were noted at the toilet: Toilet is loose at floor, Minor plumbing repairs will be needed to restore proper operation.

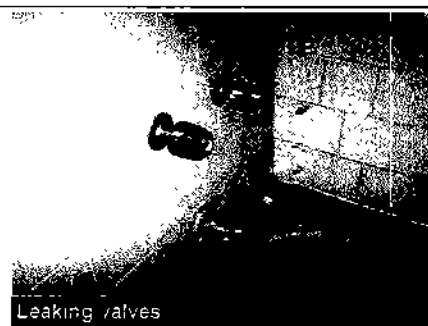
Minor leakage is noted at faucet handles.
